Case Report

Shearing osteochondral humerus fragment fixed with bio-pins

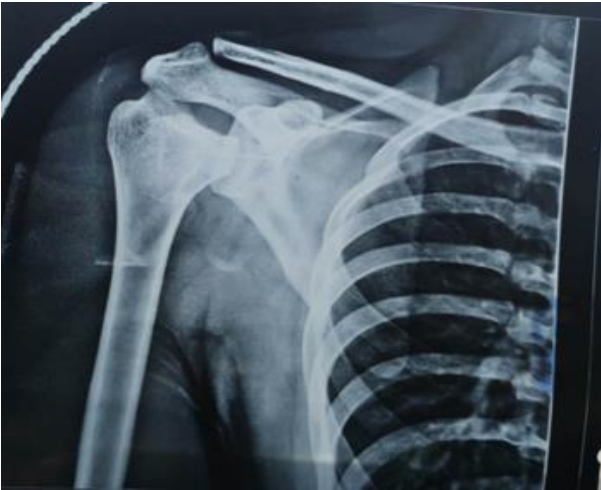
Figure 1: X-ray showing defect in humeral head.

A 24 years old male with right hand dominant came with history of fall from bike, he reported direct impact injury to his right shoulder. He was not sure of complete dislocation of his shoulder. He came with pain and complete restrictions of movements. We did a clinical and radiological investigation (X-ray and CT scan) which showed an osteochondral fragment displaced posteriorly.

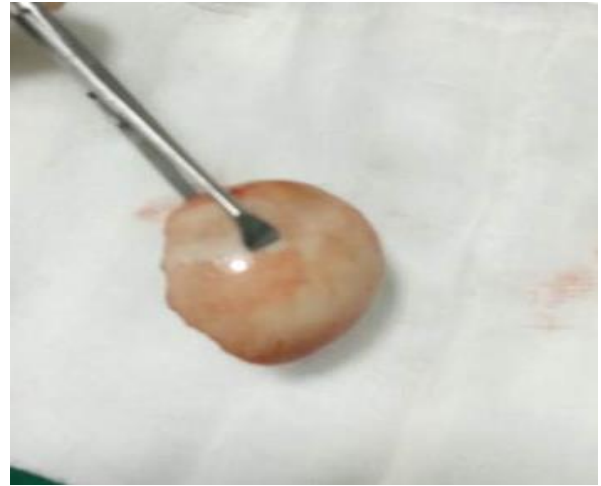
Figure 4: Osteochondral fragment.

We operated him under general anaesthesia in beach chair position. The deltopectoral approach was performed with maximum deltoid muscle preservation and tenotomy of the upper third of the subscapularis. The osteochondral fragment missing from the humeral head was “fished out” of the posterior-inferior axillary pouch. Osteochondral fragment measuring about 4×4 cms was anatomically reduced and initially stabilized with K-wire. Final stabilization done with 5 Bio-pins.

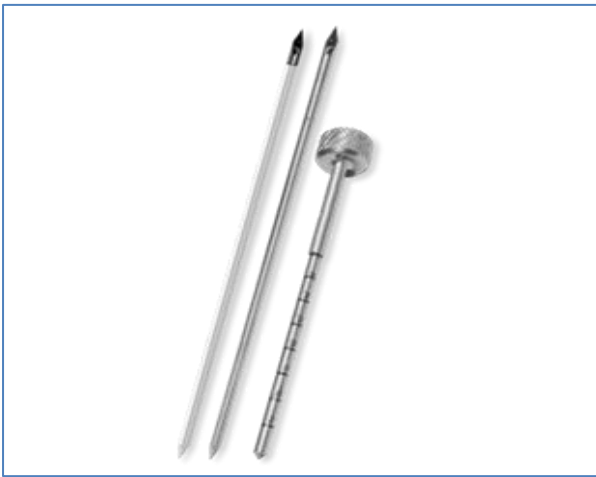
Figure 2: Arthrex bio-pin.

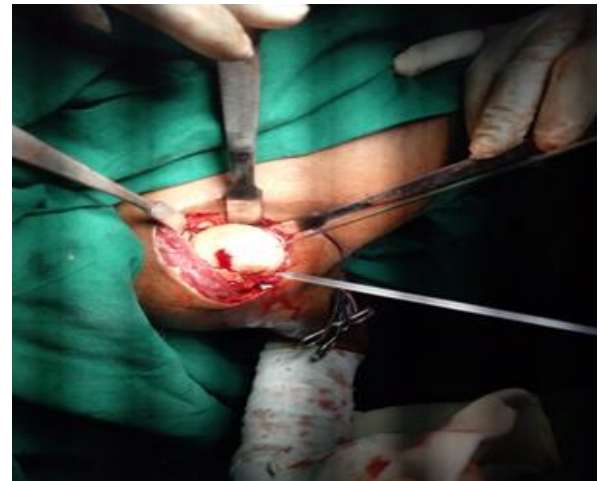
Figure 5: Bio-pin and fragment stabilized with K-wire.

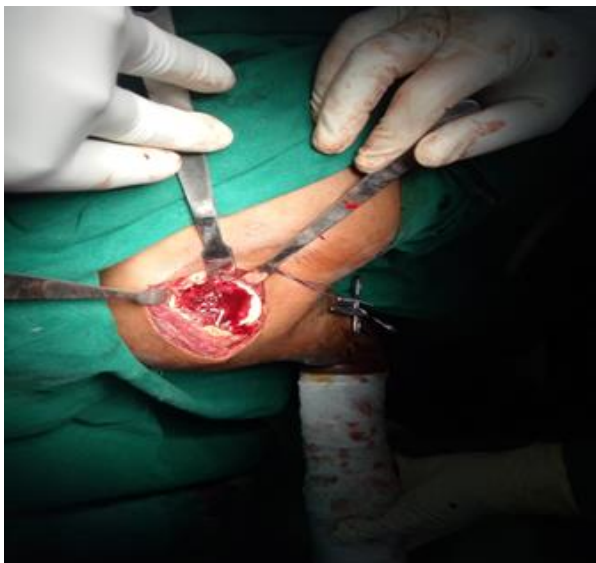
Figure 3: Osteochondral defect.

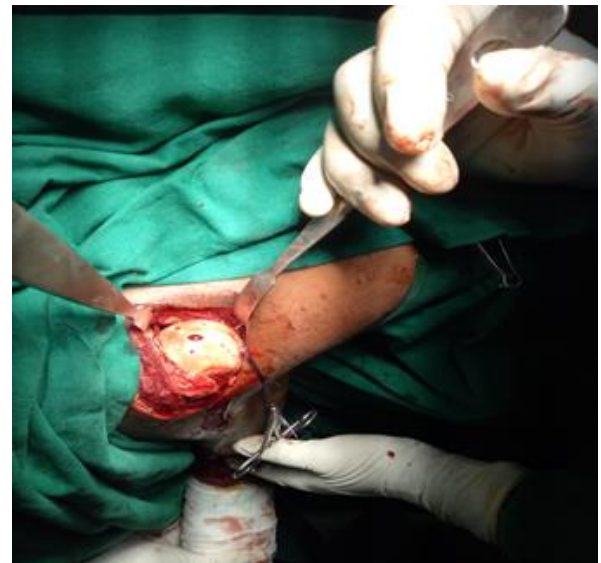
Figure 6: Fragment fixed with bio-pins.

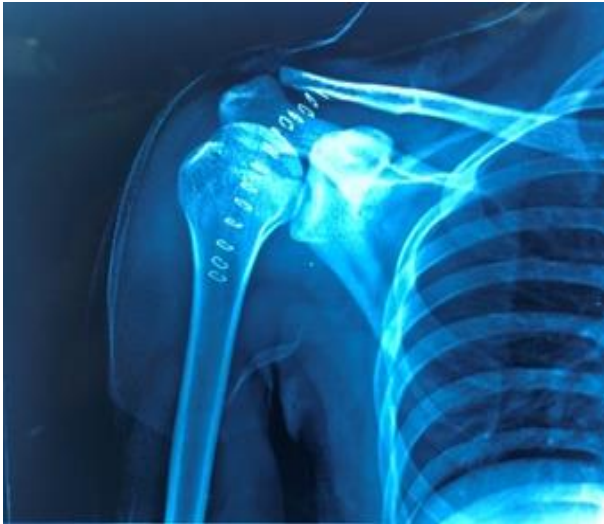
Figure 7: Immediate post-op.

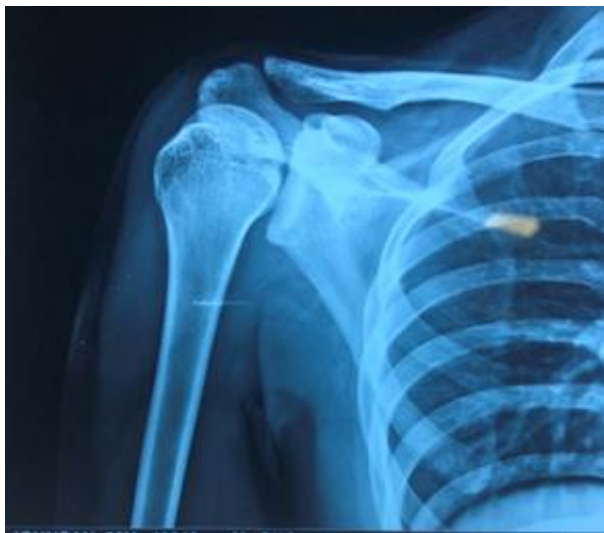
Figure 8: Six weeks post-op.
