Case Report

Novel technique of removal of broken intra-medullary nail from femur with secondary DCS plating

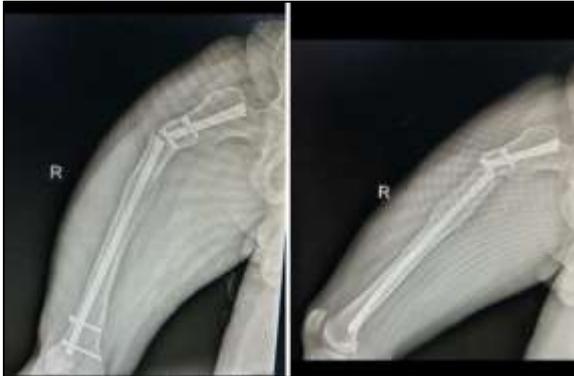
Figure 1: Pre-operative x-ray showing broken femur interlocking nail along with subtrochanteric femur fracture.

We have a 35 years old male patient who was brought to us 2 hours after an alleged history of slip and fall following which he had sustained injury to the right hip. The patient is a previously operated case of bilateral femur interlock nailing done 15 years back. On preliminary imaging, on the right side - the patient was diagnosed to have a broken implant – the interlock nail along with a sub-trochanteric femur fracture at the same level (Figure 1).

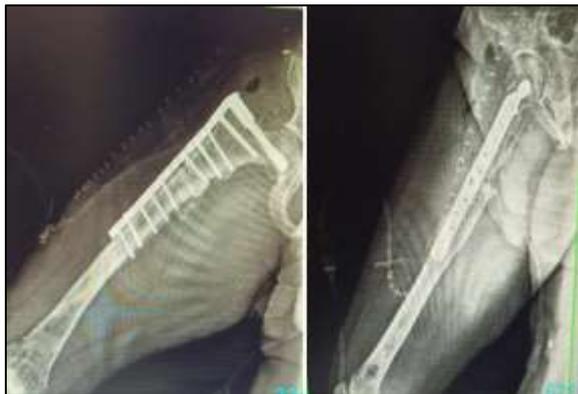
Figure 2: Immediate post-operative x-ray with implant removal done with secondary DCS plating with bone grafting.

The patient was operated with – broken implant removal on the right side along with a secondary DCS plating for the sub-trochanteric femur fracture (Figure 2). Intra operative period was met with a certain number of challenges and difficulties i/v/o a 15 year old implant for removal which was successfully with removed with DCS plating with bone grafting done.

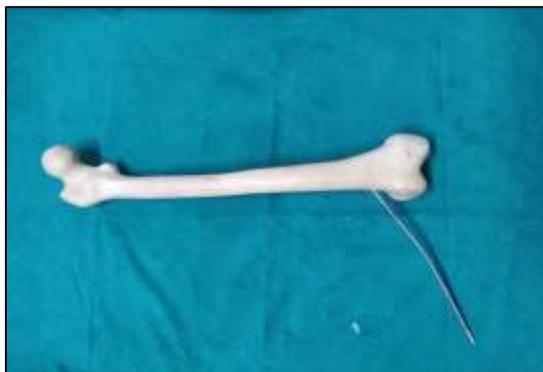
Figure 3: Cortical window made in the distal fragment in order to engage the bent Steinmann pin (AP view).

After a few attempts in vain, a unique technique was employed while removal of the distal fragment in the form of a Steinmann pin which was bent at the tip and engaged in the distal fragment after making a cortical window over the distal femur for retrieving the distal fragment (Figure 3, 4). After engaging a Steinmann pin into the fragment, a T-handle was applied and by hammering technique, the distal fragment was retrieved from the fracture site proximally (Figure 5). After the implant removal was done (Figure 6), secondary procedure with fixation with a long cephalo-medullary nail was tried initially. It was encountered with difficulty as reaming was not possible due to extensive fibrosis and adhesions over the entry site. It was intra-op decided to fix the subtrochanteric femur fracture with Dynamic Condylar Screw with side plating with bone grafting was done with an acceptable reduction

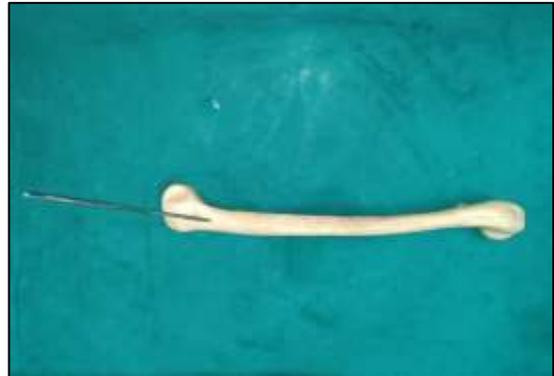
Figure 4: Cortical window in the distal femur to engage the Steinmann pin (lateral view).

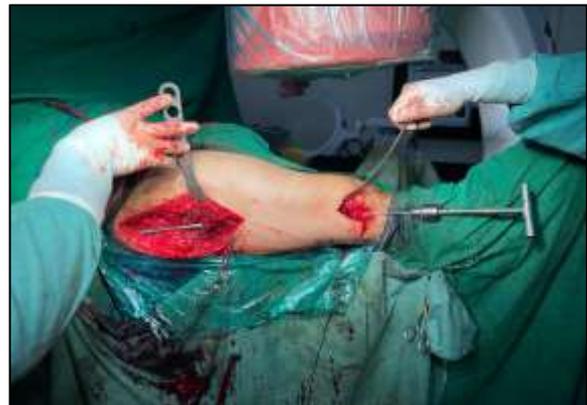
Figure 5: Distal fragment of the broken nail retrieved from the proximal fracture site after engaging the Steinmann pin distally.

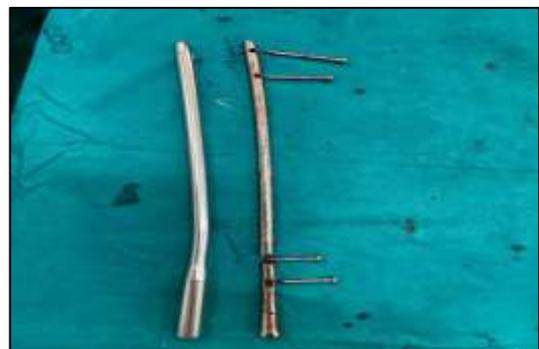
Figure 6: Removed broken femur interlock nail.
